Repair of 35 V 100 uFd electrolytic capacitor on D-20 board.

Fix to error code 5.

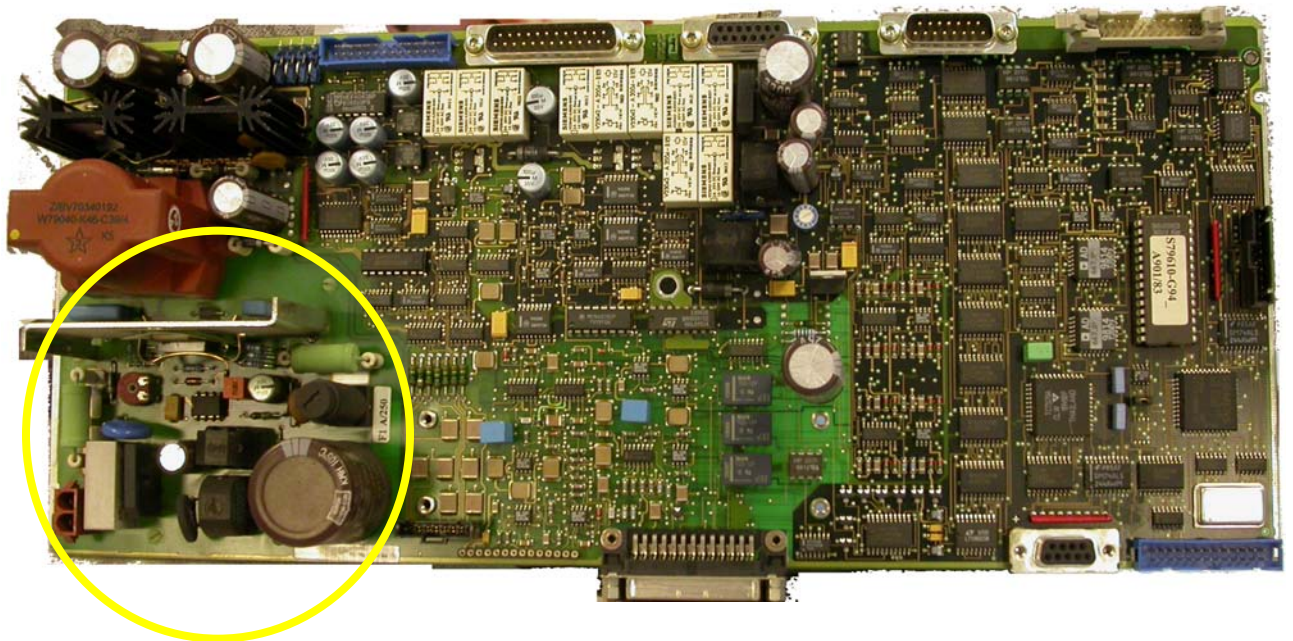
The D-20 inverter board for the K710/K760 is shown in the picture below:

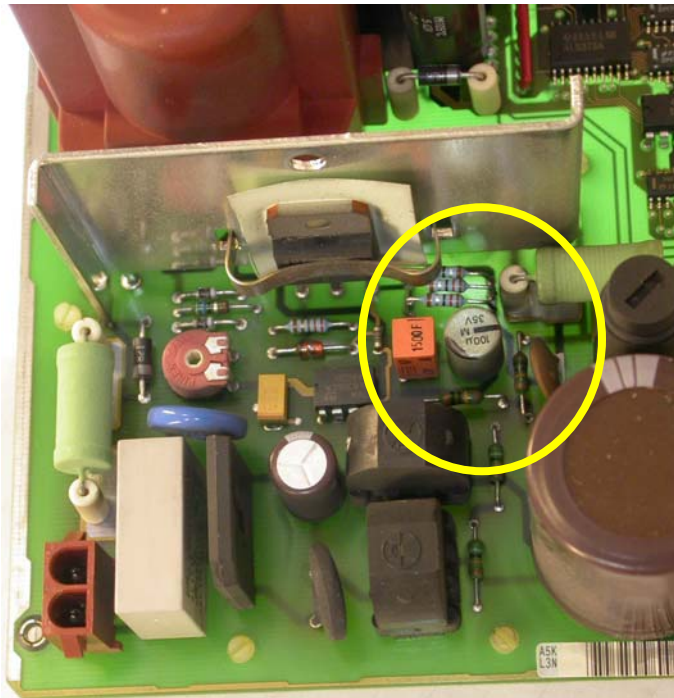
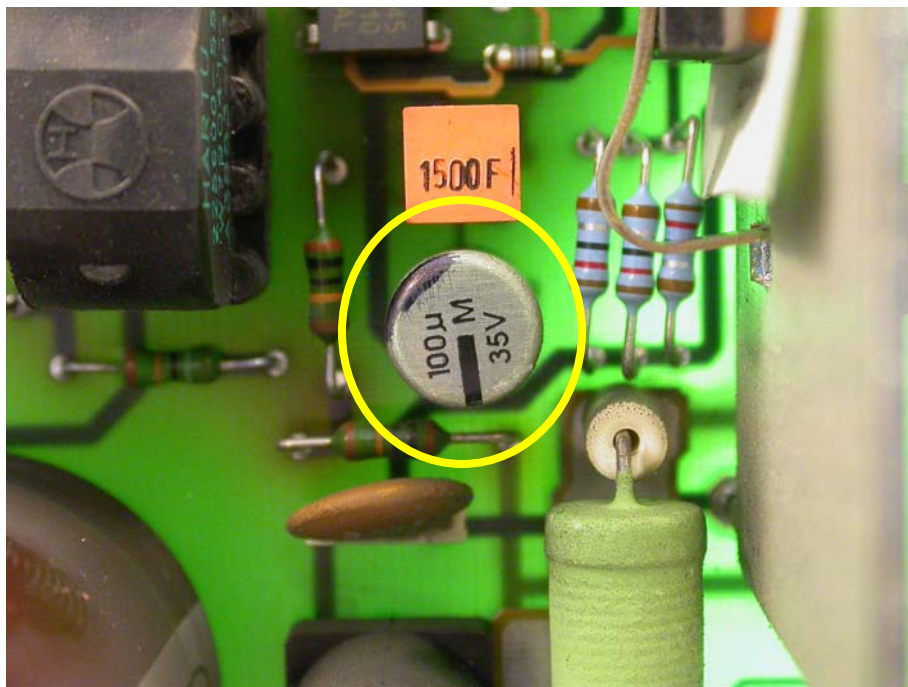
The failure mode of the D-20 board is reported as Error code 5 on the LCD display of the X-ray generator.

The following region of the D-20 card is magnified and shows the 35 V 100 uFd electrolytic surface mount capacitor that a listed failure on this D-20 board.

The 35 V 100 μ F electrolytic capacitor is replaced with a 50 v 100 μ F electrolytic alum capacitor with radial leads.

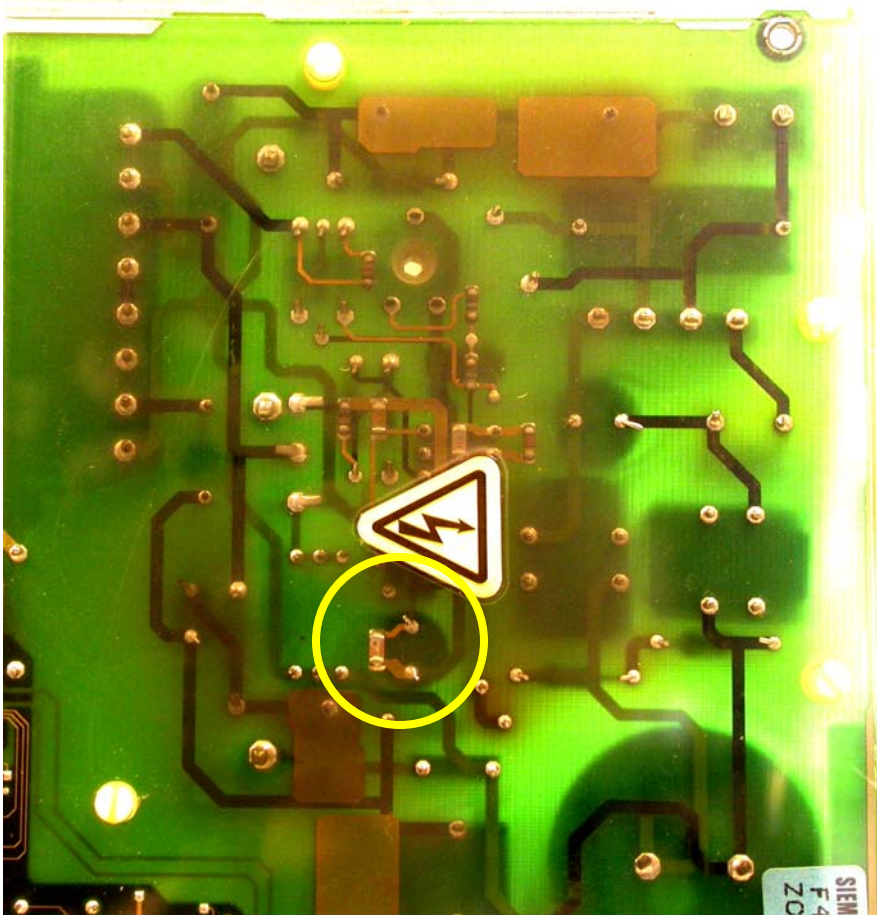
The corresponding side of this surface mount board is shown below.

The circled area indicates the pin out position for the capacitor for soldering.
